Manhole Inspection Summary

Manhole # S55G__007MH

Inspection ☐ Is Incomplete Rating: **4) Poor**

Location Address: **Gough St.**

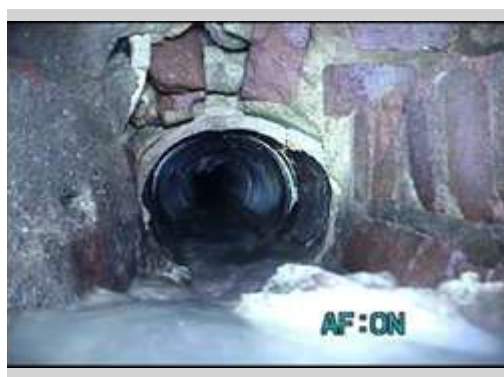
Defect 3

Condition: ☐ Sound ☐ Cracked ☐ Root Intrusion ☐ Loose Brick ☒ **Deteriorated**

deterioration in barrel wall above pipe@12

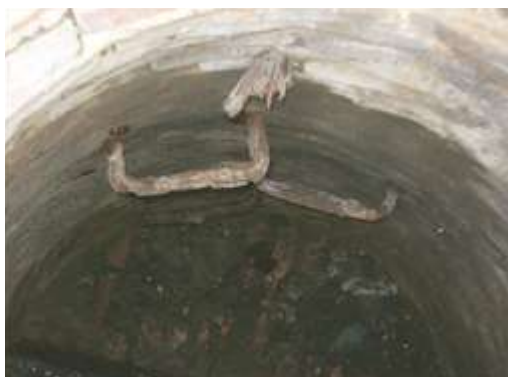
Defect 7

Steps Count: **4** Missing: **1** ☒ **Corroded**

corroded rungs and 1 missing

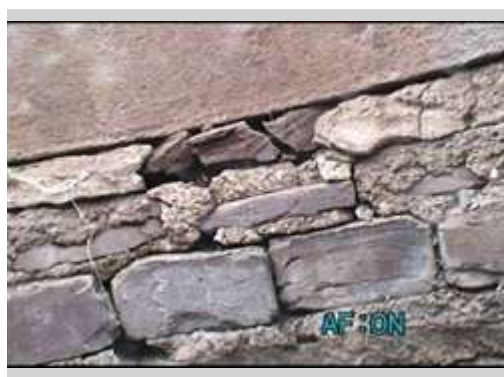
Defect 5

Condition: ☐ Sound ☐ Cracked ☐ Root Intrusion ☐ Loose Brick ☒ **Deteriorated**

deteriorated chimney

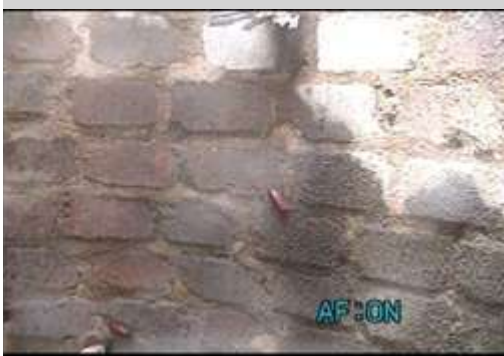
Defect 4

Infiltration: ☐ None ☐ Joint ☐ Cracks ☒ **Mortar** ☐ Roots ☐ Wall

corbel infiltration from mortar

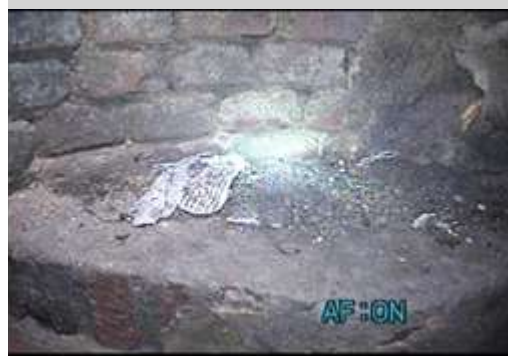
Defect 2

Condition: ☐ Sound ☐ Cracked ☐ Root Intrusion ☐ Deteriorated ☐ Leaks ☒ **Debris**

debris on bench

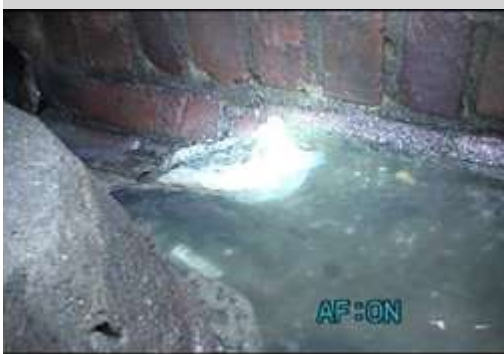
Defect 1

Condition: ☐ Sound ☐ Cracked ☐ Root Intrusion ☐ Deteriorated ☐ Leaks ☒ **Debris**

debris in channel

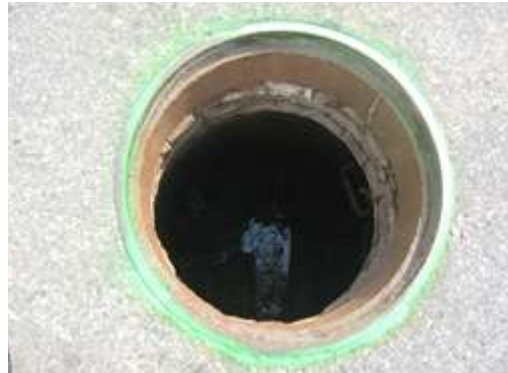
Defect 8

Frame Offset: **1.5** (in.) Condition: ☒ Sound ☐ Cracked ☐ Leaks

frame offset

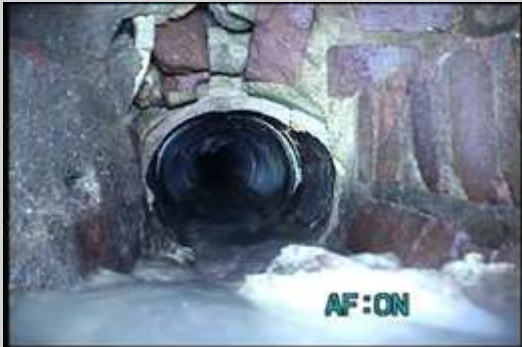
12 O'Clock Outflow

8 in. Circular Gravity Sewer
Pipe Out @ 12 O'Clock

Pipe Height: **7.2** (in.) Rod and Bar (Angled)
Pipe Material: **Clay** ☐ Pipe Lined
Invert Depth: **8.84** (ft.) Flow Characteristics: **Slow**
Deposits: ☒ None ☐ Mud ☐ Sludge ☐ Debris ☐ Grease
Silt Depth: **0** (in.) Deposits Extent:
Infiltration: **None** Pipe Seal Cond: **Cracked**
